ADVISORY CIRCULAR 43-16A

AVIATION MAINTENANCE ALERTS

ALERT
NUMBER
280

NOVEMBER
2001

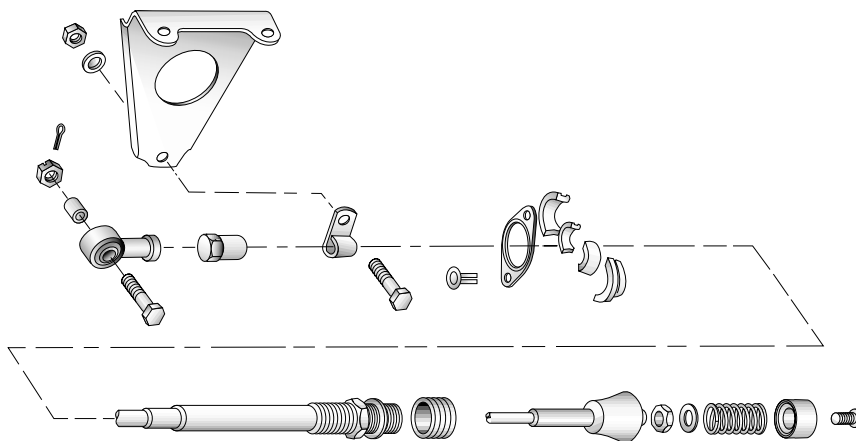
The pilot reported that during flight, the throttle control assembly (P/N 35-944046-5) jammed when it was moved. He was able to gain enough control to land the aircraft safely.

A technician found the throttle control knob button (P/N 35-944035-1) was misaligned causing the throttle interference. The screw (P/N NAS387-832-8P), used to attach the button to the throttle knob, was loose and allowed the button to become misaligned and jam when the throttle was moved. The screw had backed out approximately eight turns. (Refer to the illustration.)

This rather small screw being loose could have resulted in a catastrophic aircraft accident, and technicians and pilots should pay extra attention to the security of all hardware.

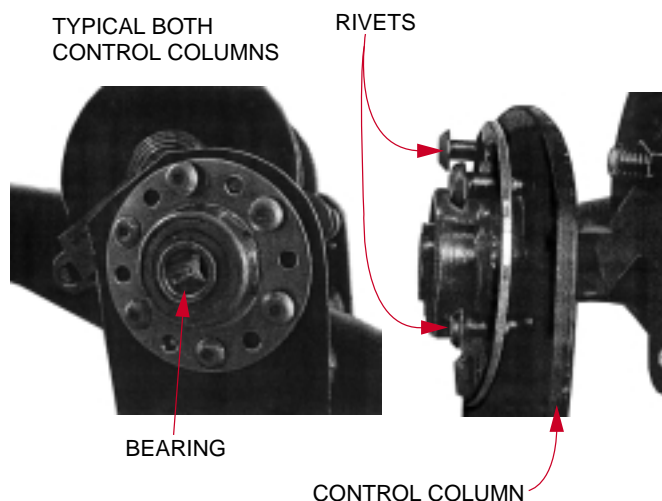
A technician discovered that excessive movement of the control column was required before the elevator moved. Further inspection revealed the control column assembly (P/N 100-524119-55) lower bearing (P/N MS20218-2) was loose, and the attachment rivets (P/N NAS1738B4) were worn and backed out. Similar defects were found on both control columns. (Refer to the illustration.)

The submitter suggested that technicians give this area extra attention during scheduled inspections.

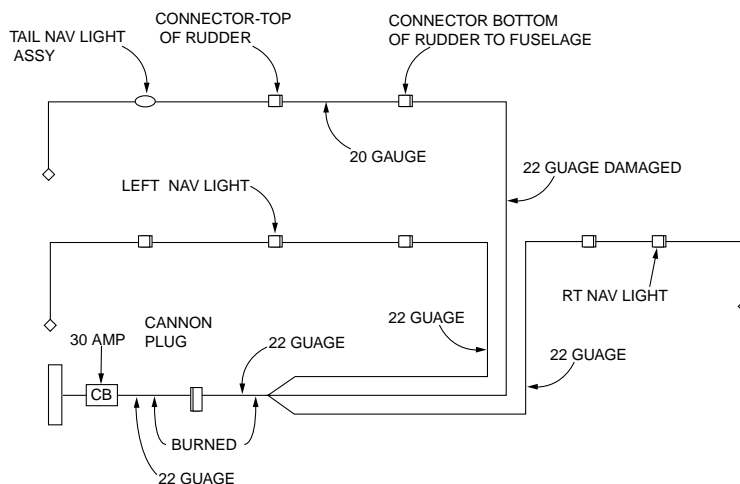
A technician inspected the aircraft and found a 22-gauge wire (2H1002), was burned from the navigation light circuit breaker switch to pin 11 in connector JC001 and from there to pin 1 in connector JV001. The red wire (6-inch pigtail) from the tail navigation light housing, running to the connector (JV001), was shorted to a nut plate used to attach the rudder tip. However, other than a small “pin-sized burn mark,” the wire did not display evidence of overheating.

Several other wires (2H1005, 2H1009, and 2H1008) were severely damaged. All three wires from the navigation lights feed into a 2-foot length of 22-gauge wire that is connected to the 5-amp circuit breaker switch. (Refer to the illustration.) Most of the wire to the tail navigation light was damaged; however, the forward portion of the wire was burned down to the bare conductor. This part of the wire melted into adjacent wires in the bundle causing an electrical overload that opened the 30-amp navigation light system circuit breaker.

The submitter offered evidence indicating the electrical system, for the navigation light circuit, required between 18-gauge wire and 20-gauge wire instead of 22-gauge wire. It is believed the inadequate wire size contributed to, or caused, this failure. It was recommended that the manufacturer consider a redesign of the navigation light circuit to alleviate recurrence of this problem.

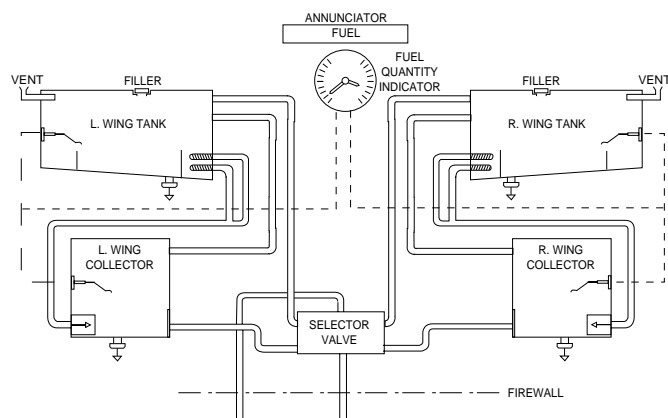
While investigating this report, a technician found that the fuel quantity transmitter, installed in the right collector tank, was operating correctly. Further investigation revealed that the right collector tank fuel inlet line, from the right main fuel tank check valve, was “glued” closed. He suspected the foreign material (glue) was deposited on the check valve when the aircraft was manufactured.

the collector tank through the upper vents connecting the collector tank to the main tank when the fuel level in the main tank was over one-half. (Refer to the illustration.)

The manufacturer's technical data indicates the front and aft fuel supply lines from each main tank connect to a single "tee" installed in each collector tank. The submitter believes that changing to two supply lines feeding each collector tank may help. This particular aircraft was originally certificated with a Textron Lycoming, Model IO-360 engine as a Model SR-20 and is now equipped with a Textron Lycoming, Model IO-550 engine which demands a greater fuel supply.

The submitter is knowledgeable of other like aircraft that have had similar discrepancies and reminds us that this creates the very hazardous possibility of engine fuel starvation, which usually occurs when it is most needed.
